# Original Article Biofilm formation is a cause of ureteral resonance metallic stent blockage: a case report

Ludong Qiao<sup>1</sup>, Wei Yan<sup>1</sup>, Zhen Du<sup>1</sup>, Qing Cai<sup>2</sup>, Shan Chen<sup>1</sup>

<sup>1</sup>Department of Urology, Beijing Tongren Hospital, Capital Medical University, Beijing, China; <sup>2</sup>Medical Experiment and Test Center, Capital Medical University, Beijing, China

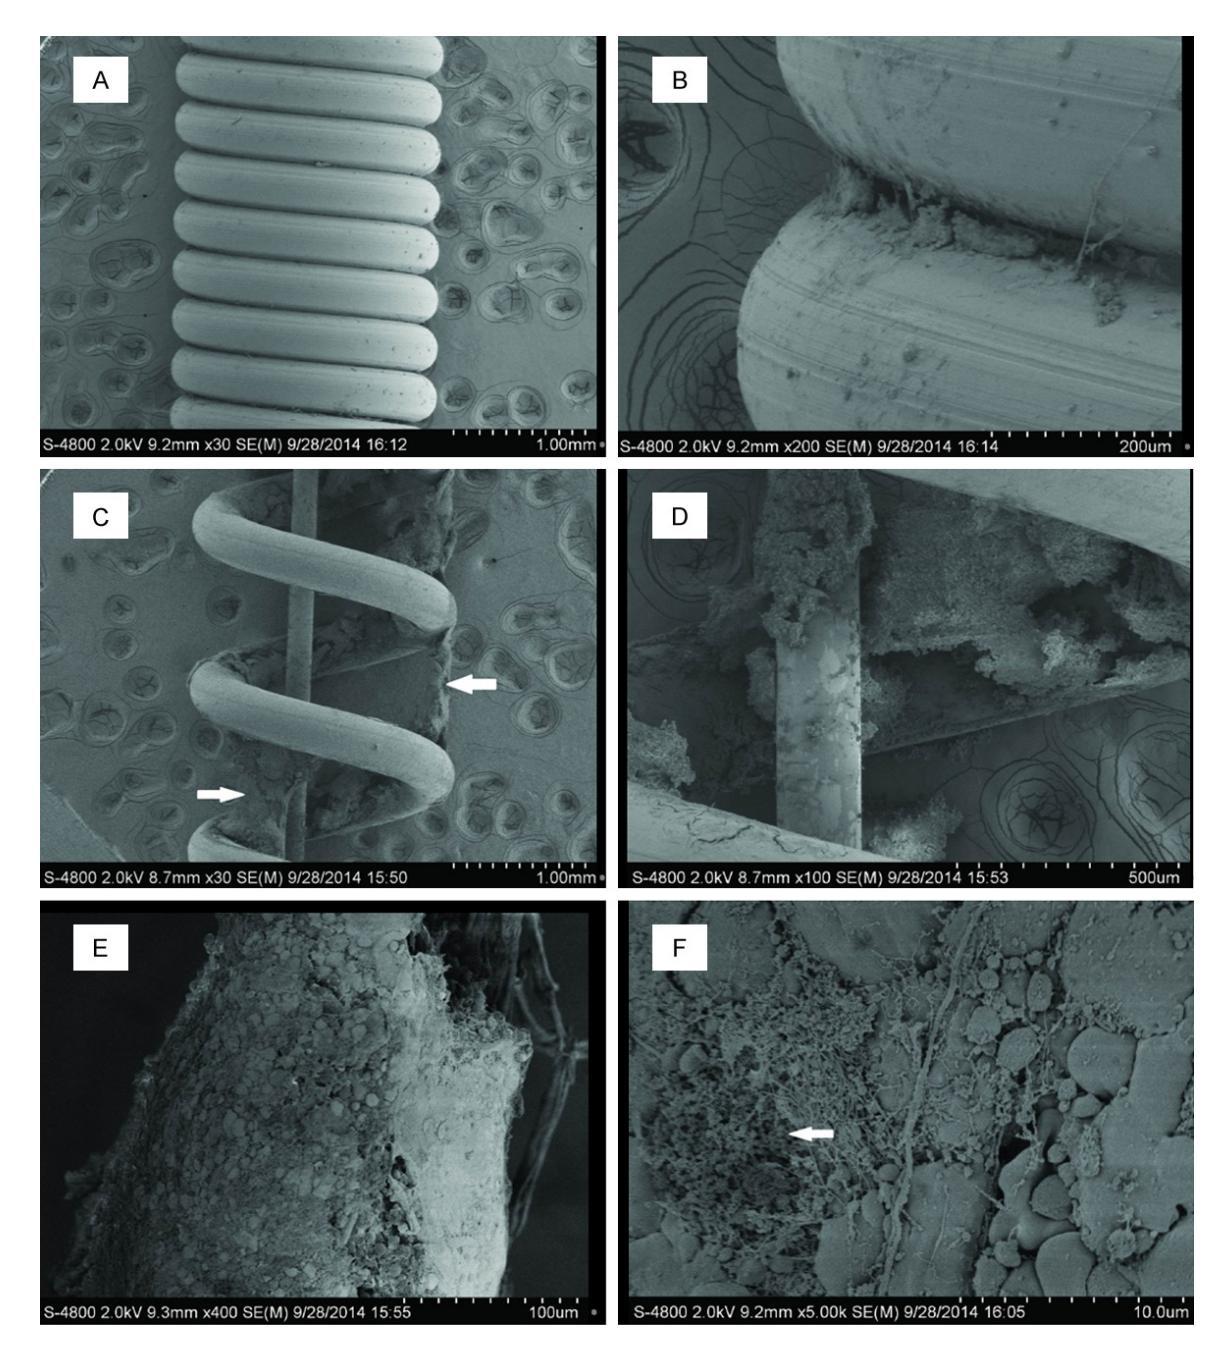
Figure 1. A. SEM ( $\times$ 30) revealed the stents was clear on the surface; B. SEM ( $\times$ 200) revealed the crevice of spiral coil of the stent was filled by biofilm; C. SEM ( $\times$ 30) revealed fibrin and biofilm were filled in the crevice of spiral coil (arrow) and lumen of the stent; D. SEM ( $\times$ 100) revealed the lumen of the stent was filled by biofilm; E. SEM ( $\times$ 400) showed the biofilm in the lumen of the stent; F. SEM ( $\times$ 5000) showed the fibrin, coccus (arrow) and biofilm.

deformities, tortuousity, fracture or stone formation. 2 weeks later, we performed bilateral percutaneous nephroscopy under general anesthesia and found no stone in both kidneys. Then the two resonance metallic stents were removed by nephroscopy for detection. The stents surface was clear. We cut the stents into 1 cm pieces and pull some pieces stretch for culture and scan electron microscopy (SEM) examination. The stents cultures revealed small quantitys of Staphylococcus epidermidis. The SEM results showed that lots of fibrin, coccus and biofilm were filled in the crevice of spiral coil and lumen of the stent (Figure 1A-F). Now the patient kept the nephrostomy tubes and the creatinine level and urea nitrogen level were 507 µmol/L and 23.3 mmol/L respectively 1 month after operation.

Cases of ureteral resonance metallic stents failure have been reported [1]. The inducements include encrustation, kinking damage, deposits between the coils and material flattening and the deformities on the stent surface. As to this case, the two ureteral resonance metallic stents showed no encrustation, damage or deformities. The SEM results revealed amounts of fibrin and bacterial biofilm filled in the crevice of spiral coil and lumen of the stents. Some coccus could be seen in the biofilm. The resonance metallic stent has a unique design without end holes: Urine drainage takes place through the tight spiral coil that makes the stent flexible and moveable. The latter characteristic allows the space to open between coils, which permit fluid access to the lumen [5]. Combined with the result of stents culture, we thought it is the bacterial biofilm formed by Staphylococcus epidermidis which stuck the drainage ways of ureteral resonance metallic stents.
